**Subject: Compliance status of Environmental Clearance for Captive jetty at Dharamtar, Dolvi, Raigad, Maharashtra**

We are hereby submitting the six monthly compliance report for the months June 2019 to November 2019.

## COMPLIANCE STATUS OF CAPTIVE JETTY AS PER ENVIRONMENTAL CLEARANCE UPTO NOVEMBER, 2019

*Report on*  
**Monitoring - Expansion of Dharamtar Jetty facility  
at Dolvi, Raigad, Maharashtra**

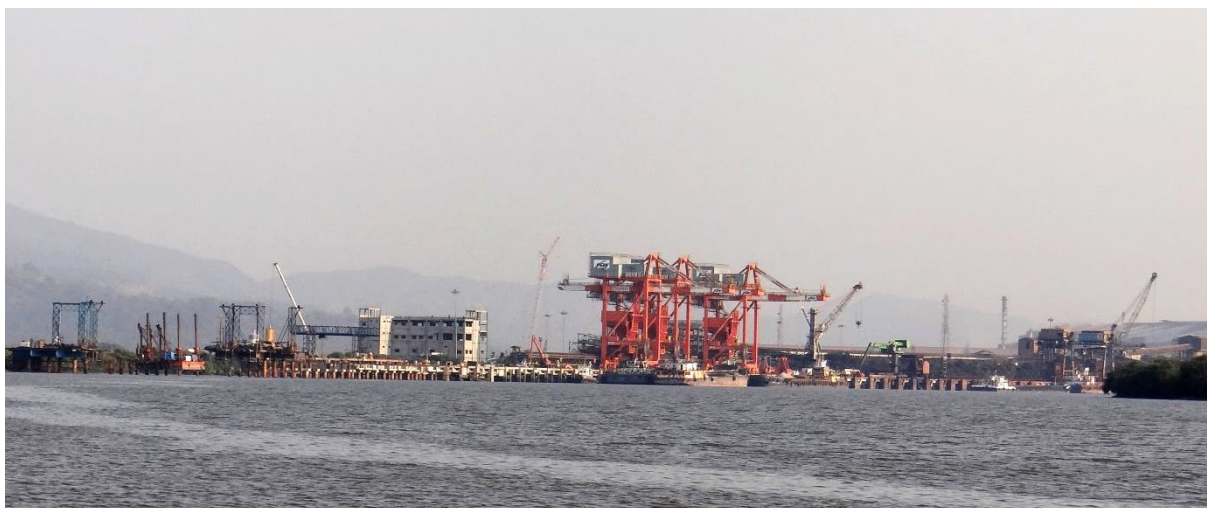
*Fig. 1: Panoramic View of JSW Port, Dharamtar*

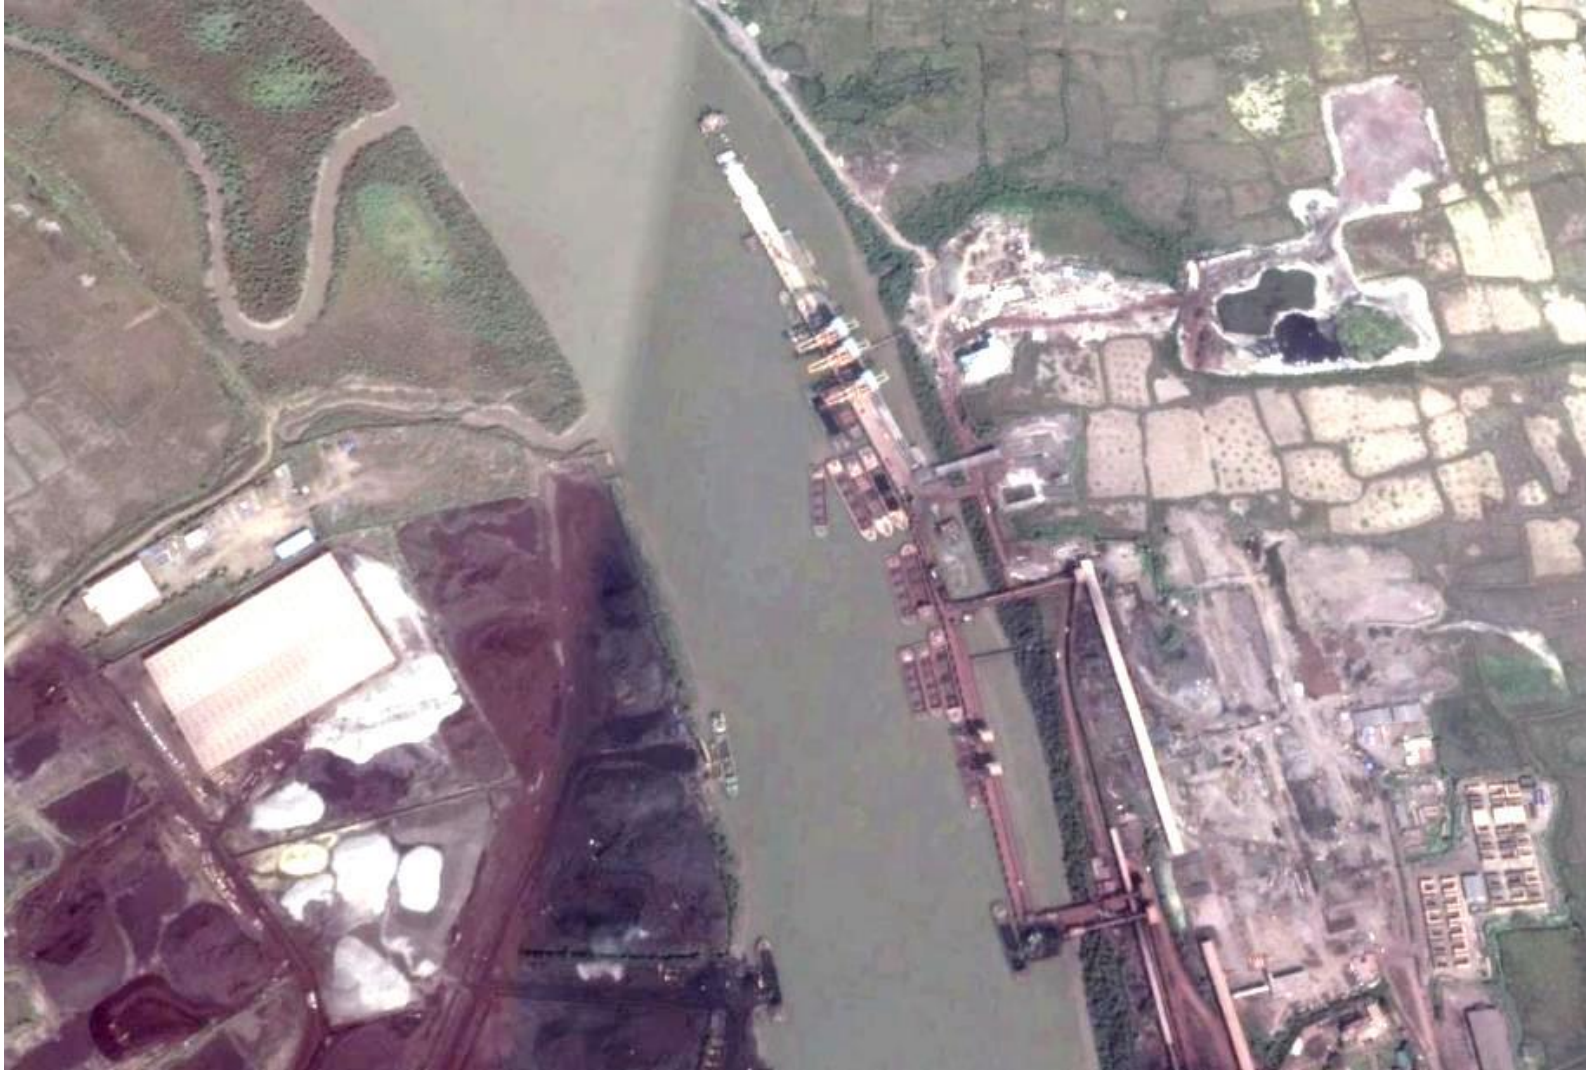
Fig. 4: JSW Dharamtar Port Private Limited showing the existing berth and ongoing construction  
(as on 22<sup>nd</sup> Oct 2016; Google Earth Image)

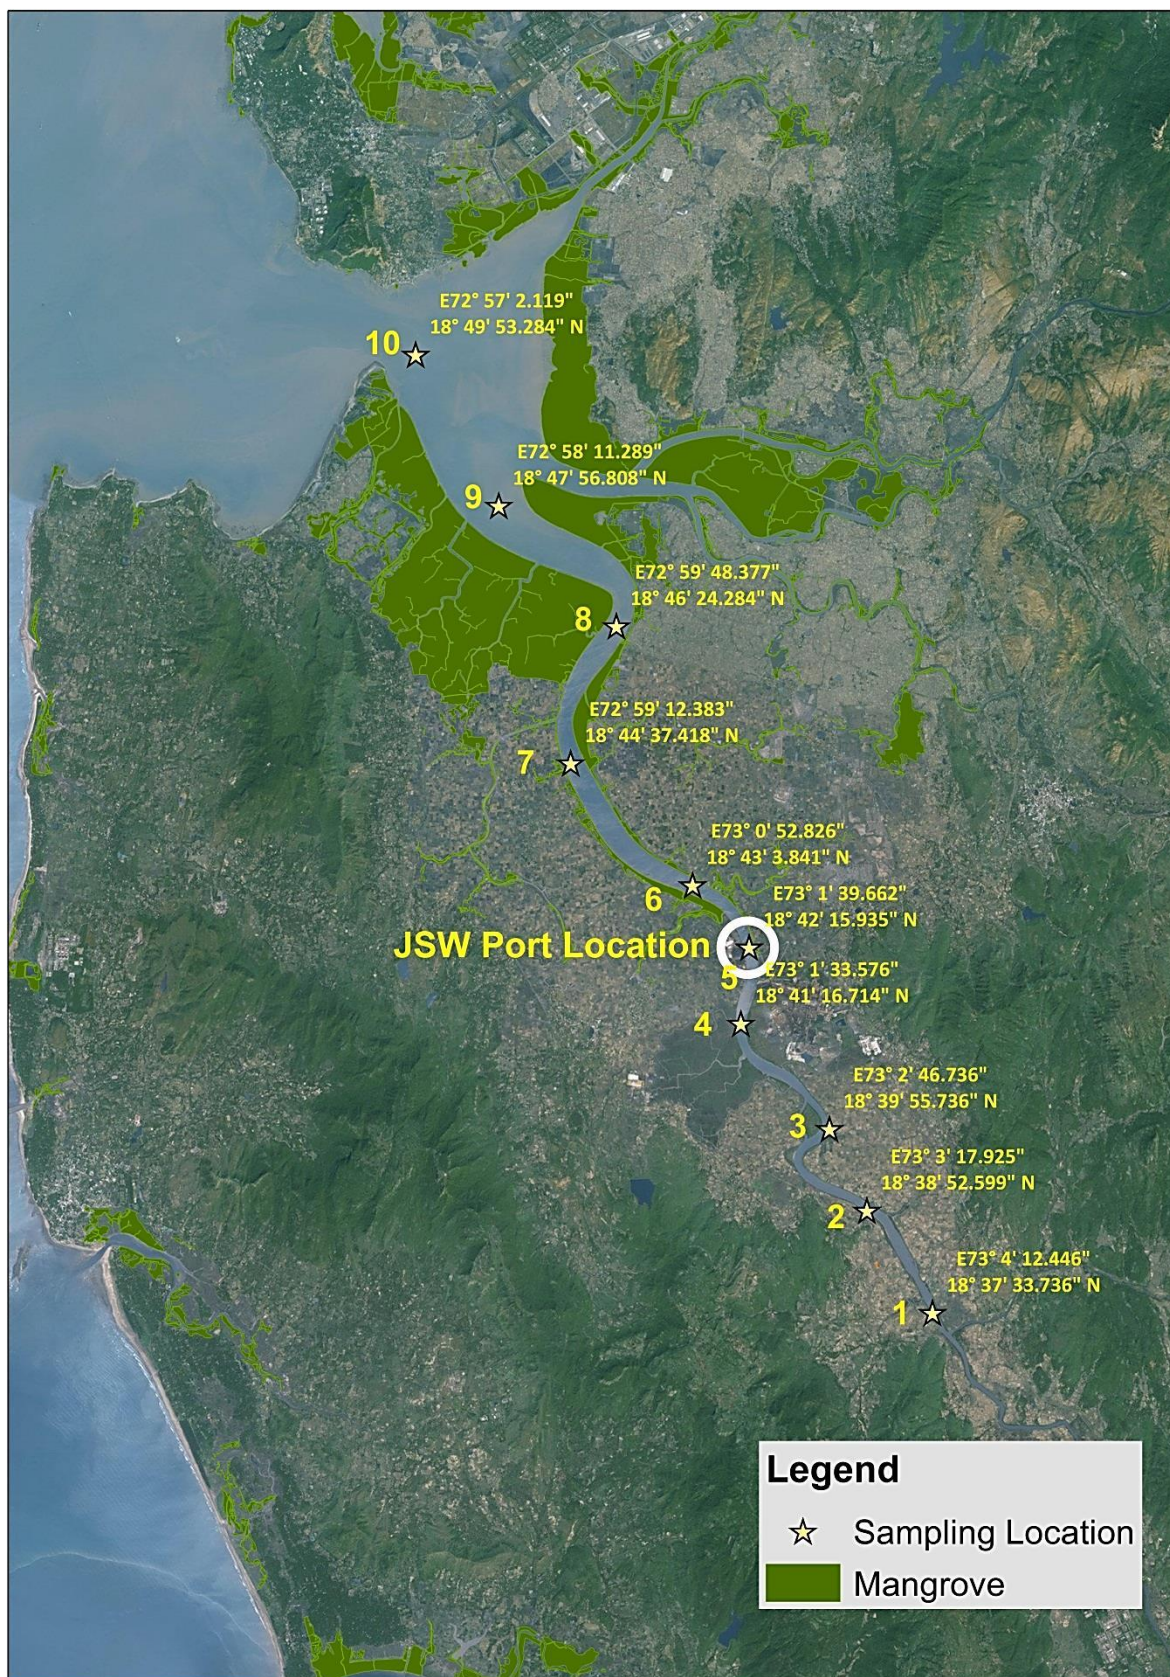
- Coastal erosion was observed near Bhal on the right bank of Amba River (18°46.98'N, 73°0.052'E),
- A total 10 stations covering the upstream, port and downstream regions of Amba River were selected for periodic monitoring (Fig 5).

Fig.5: Sampling locations for periodic monitoring in Amba River

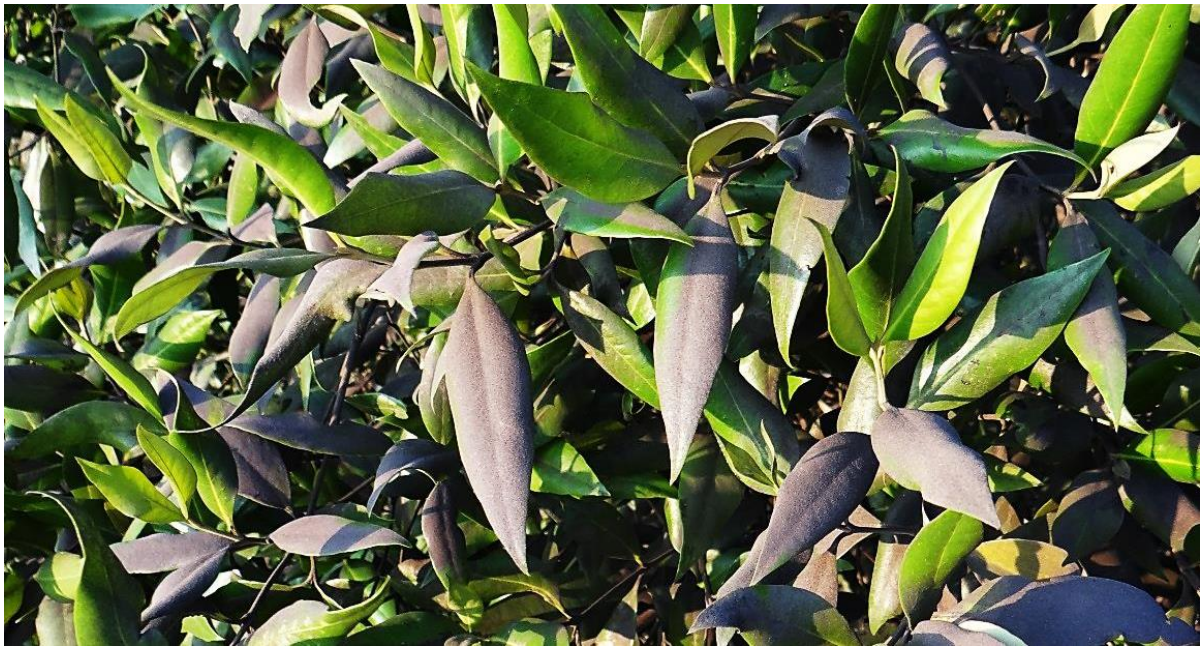
*Fig. 6: Deposition of fine dust on mangrove leaves near Dharamtar Jetty.*

In the preliminary survey along the Amba River, 6 species of mangroves were identified from the banks of the estuary and the port extension area (Fig 21). The mangroves of Amba Rivers were healthy, and initial observation indicated that the construction work for the expansion of the berth is causing minimal hindrance of flow to the mangroves in vicinity of the Dharamtar port. However the mangrove leaves near the existing berth were covered with fine dust which may impinge their photosynthetic capacity (Fig 6).

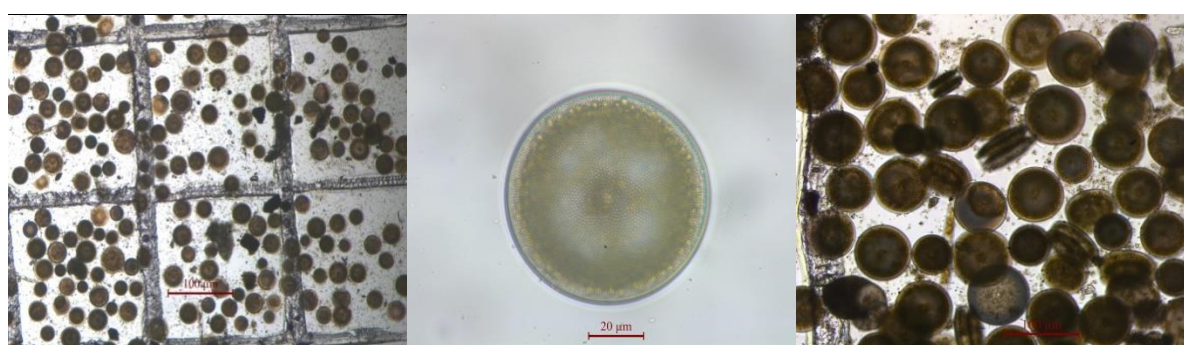
During the survey in Amba River, *Coscinodiscus oculus-iridis* was observed as the most dominant diatom (99.9% based on Sedgewick-Rafter counting method). The data suggested *C. oculus-iridis* as a bloom forming species; with population density of ~ 350000 Cells/L. As diatom blooms are non-toxic, fish mortality was not observed during the survey. However, this species dominated over other phytoplankton species.

Fig.11: Microscopic view of the bloom-forming diatom *Coscinodiscus oculus-iridis* (a) 10x, (b) 20x & (c) 40x.Sedgewick Rafter Counting Chamber

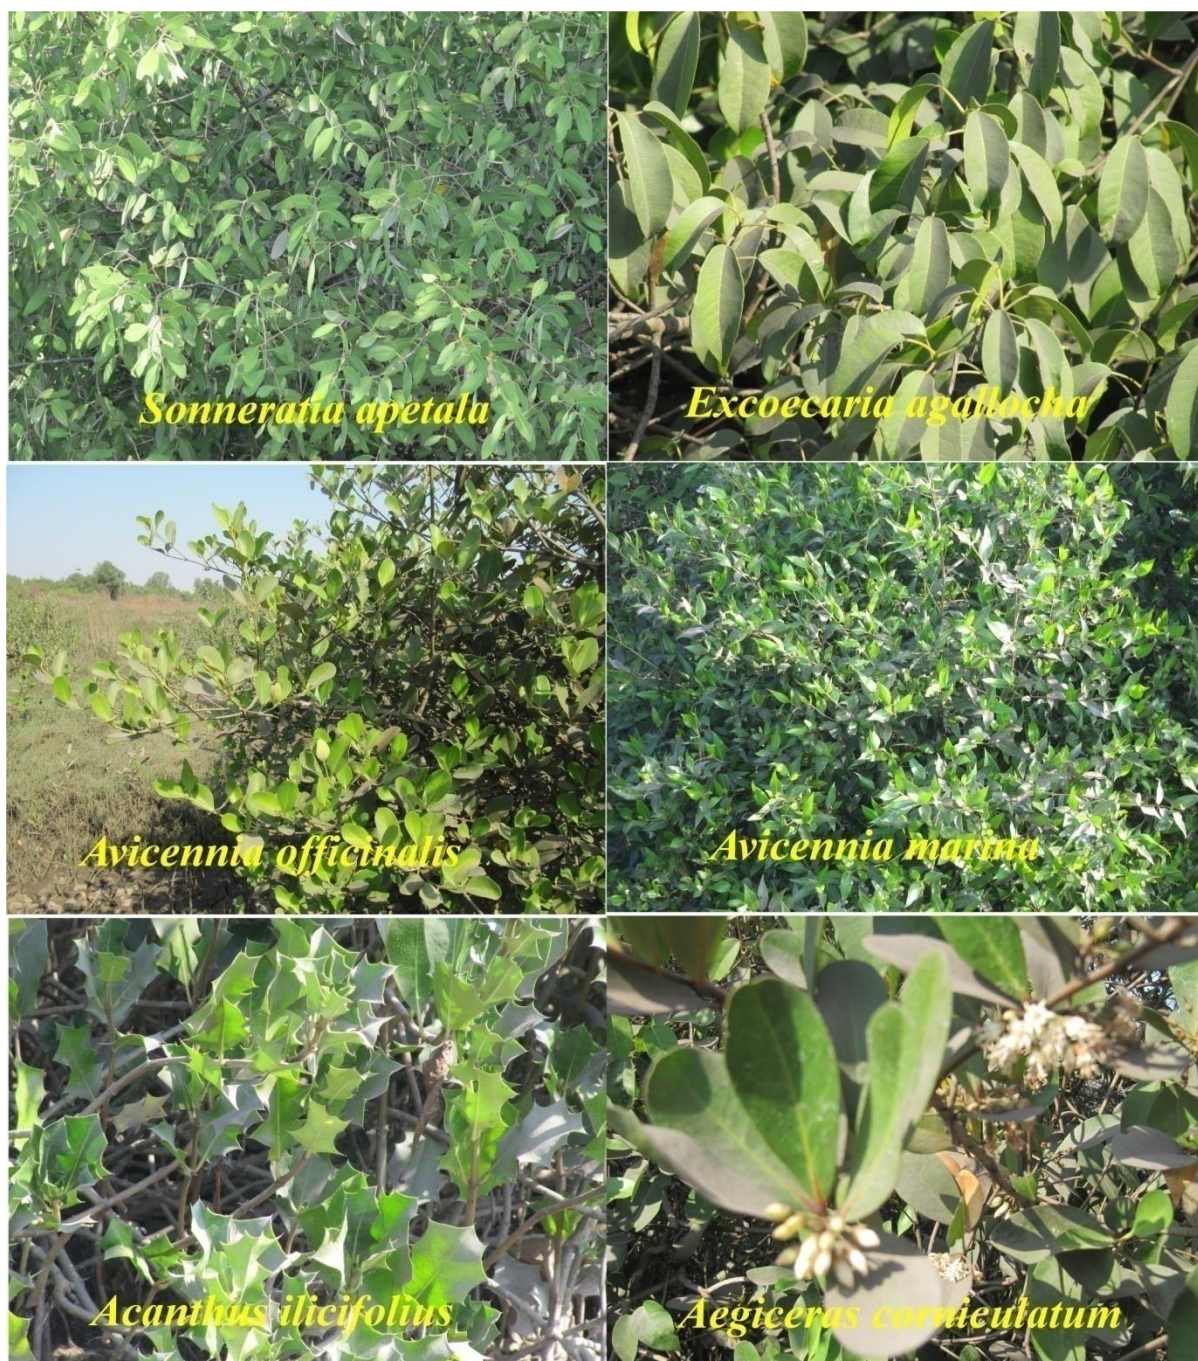
Fig. 21: Mangroves of Amba River

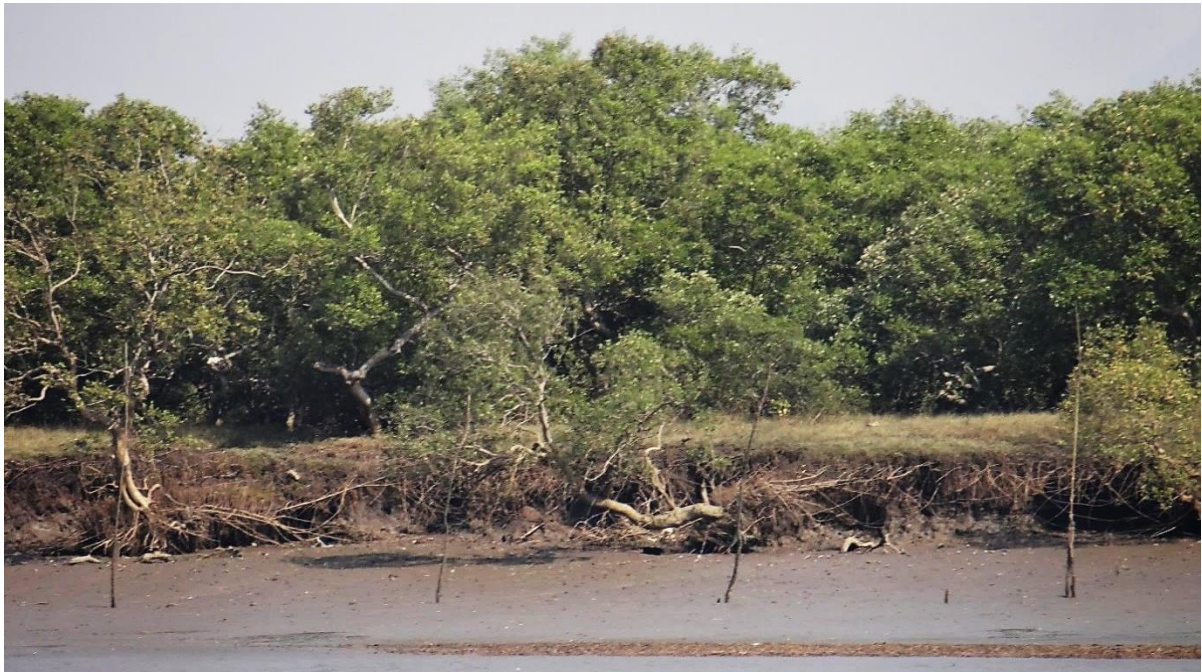
In addition, on either side of the river bank downstream, erosion was observed along with dead and exposed mangroves (Fig. 22). There are several on-going activities such as river bed sand mining at upstream of Dharamtar port (Fig 23) which may alter the hydrology of the river causing the erosion. Detailed field studies and hydrodynamic modelling studies will be carried out for the mangrove management plan.

*Fig. 22: Severe bank erosion leading to death of mangroves in downstream of Amba River*

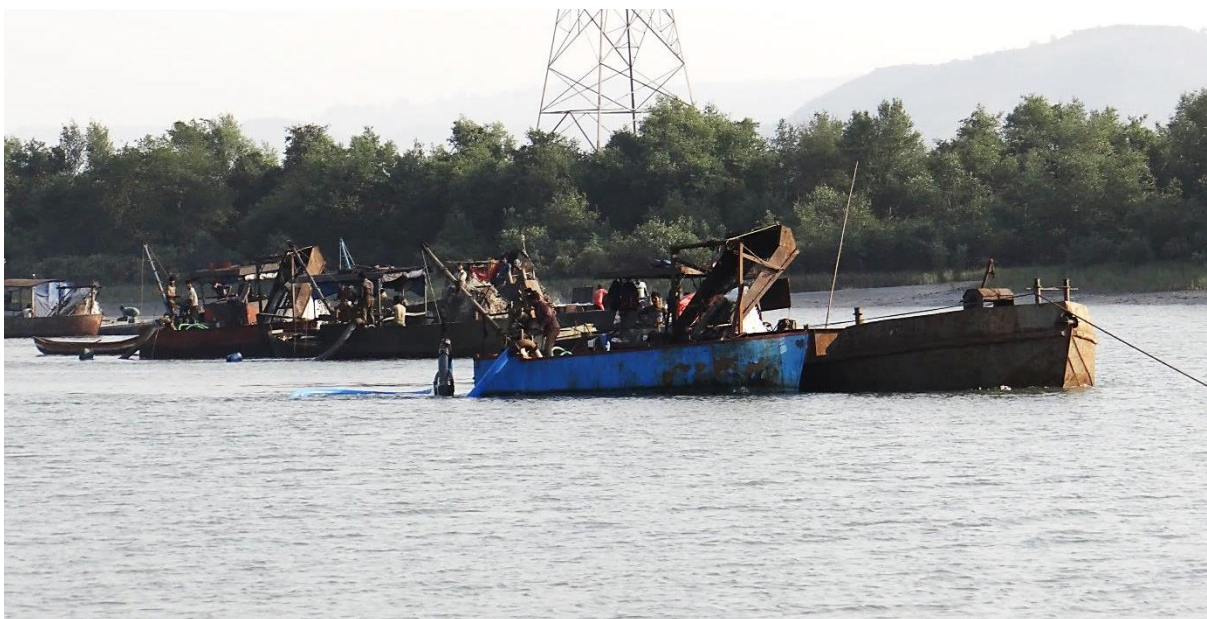
*Fig. 23. Sand mining activity in Amba River, upstream of the JSW port*

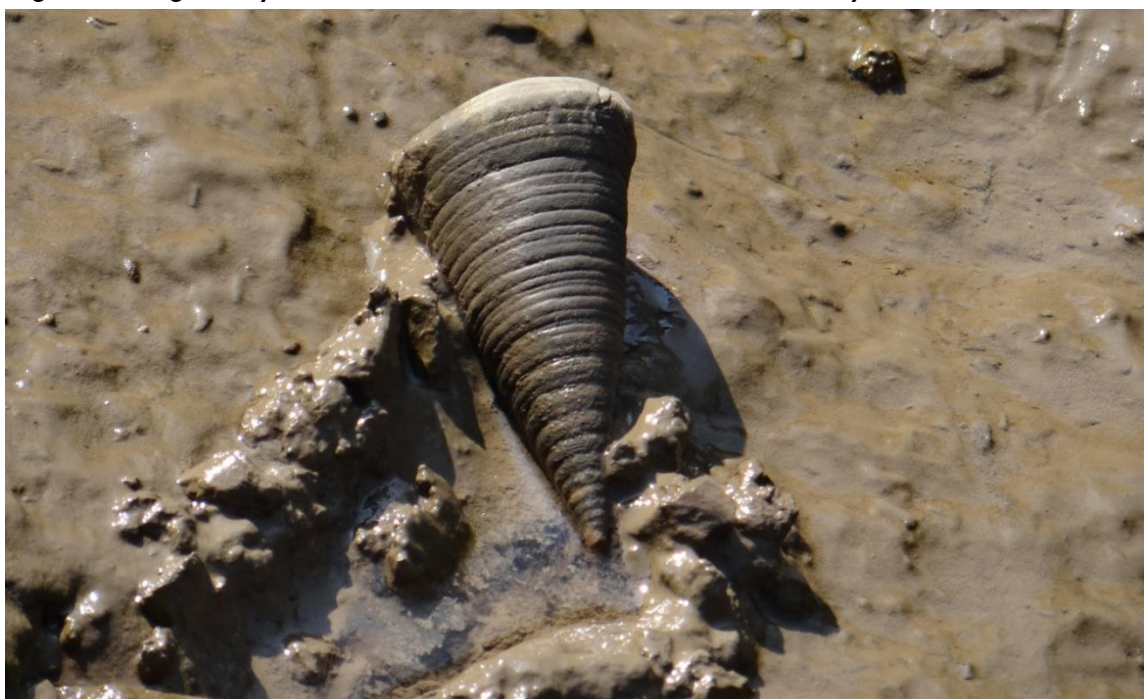
Molluscan forms namely the Horn snail *Telescopium telescopium* (Gastropoda) and the rock oyster *Saccostrea* (Bivalvia) were found in the estuarine regions. While the horn snail was found in the intertidal zones of the estuary amidst mangroves, the rock oysters were found attached to concrete structures and rocks (Fig 25)

Fig. 25: Horn snail *Telescopium telescopium* foraging in the intertidal area

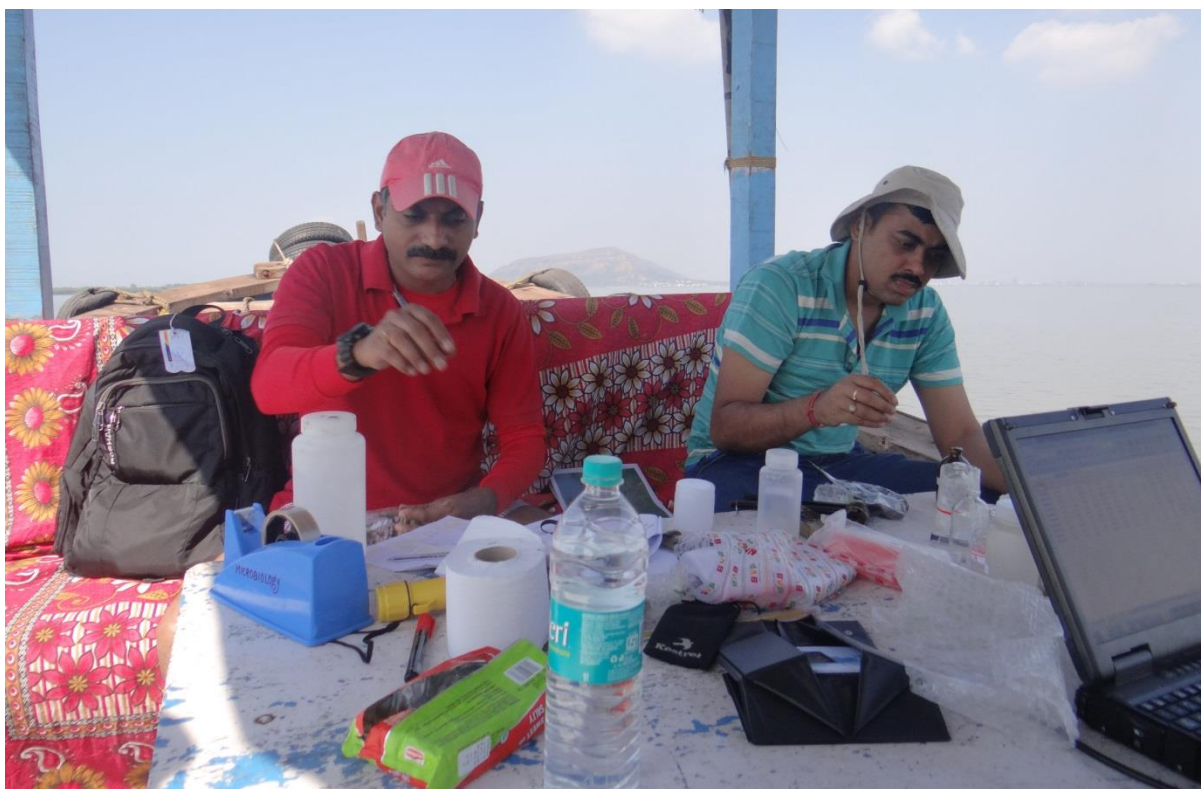
*Fig.28: In situ measurements during the field visit in Amba river*

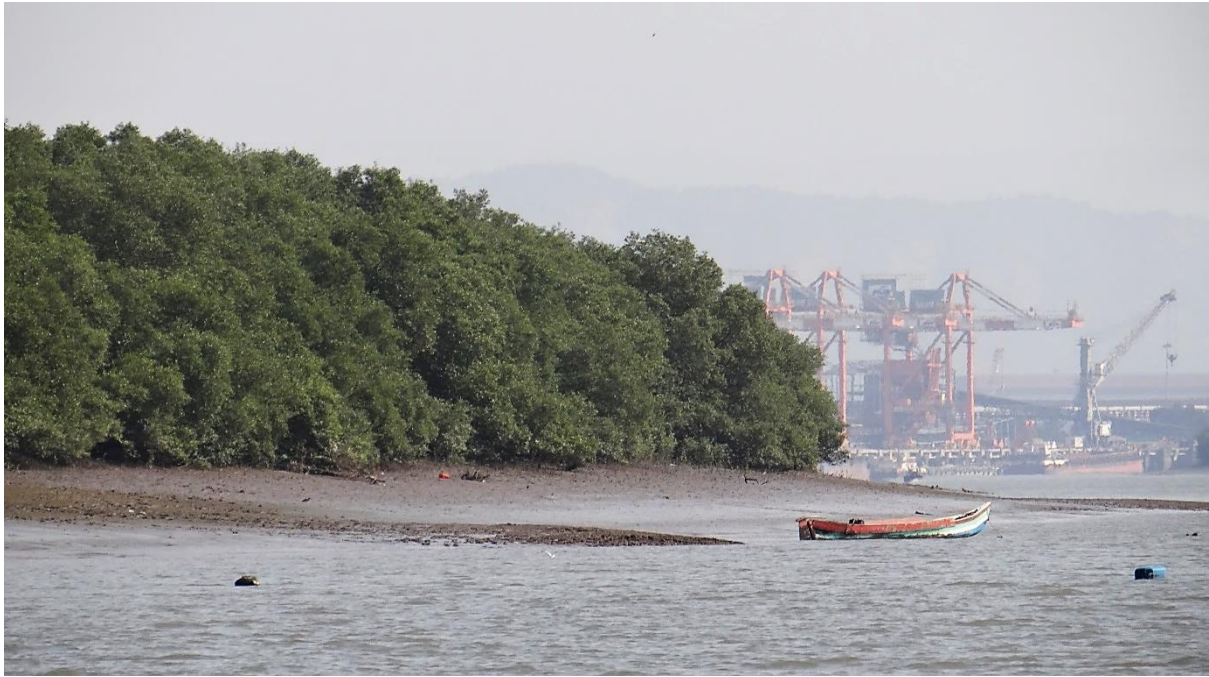
*Fig. 30: Mangroves of Amba River near the JSW Dharamtar Port*

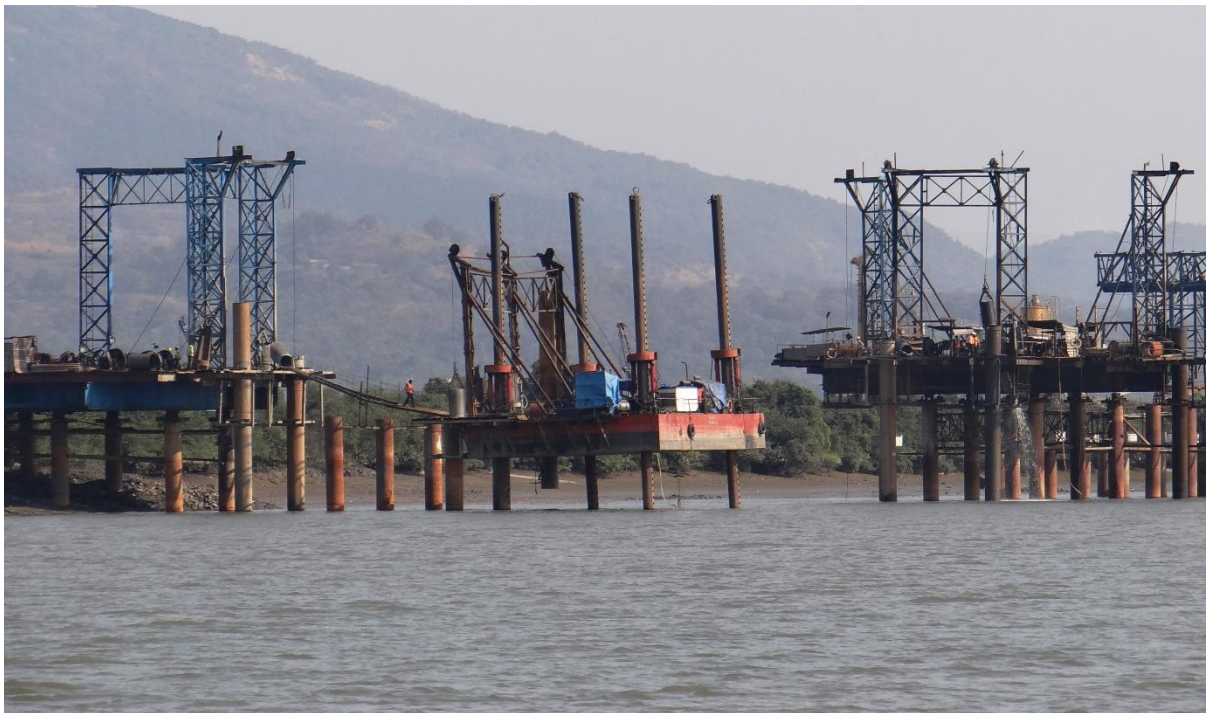
*Fig. 31: On-going construction activities at JSW Dharamtar port. Mangroves are clearly visible behind the construction site.*

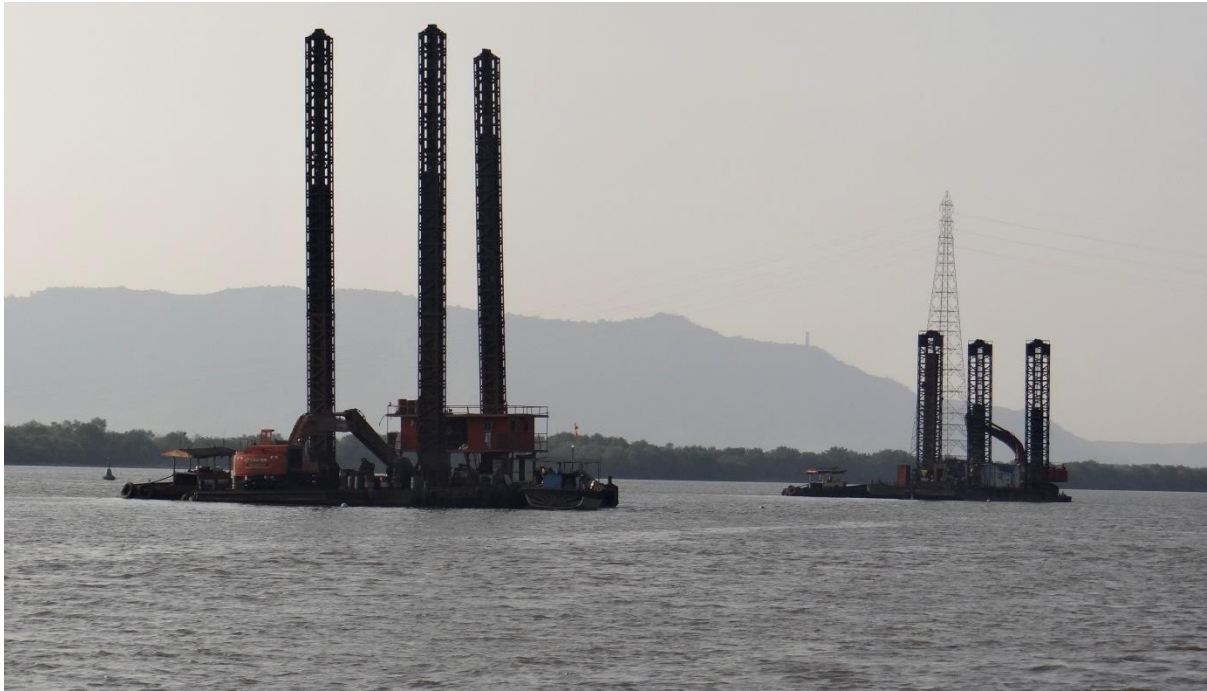
*Fig. 32: Dredger in downstream of Amba River*

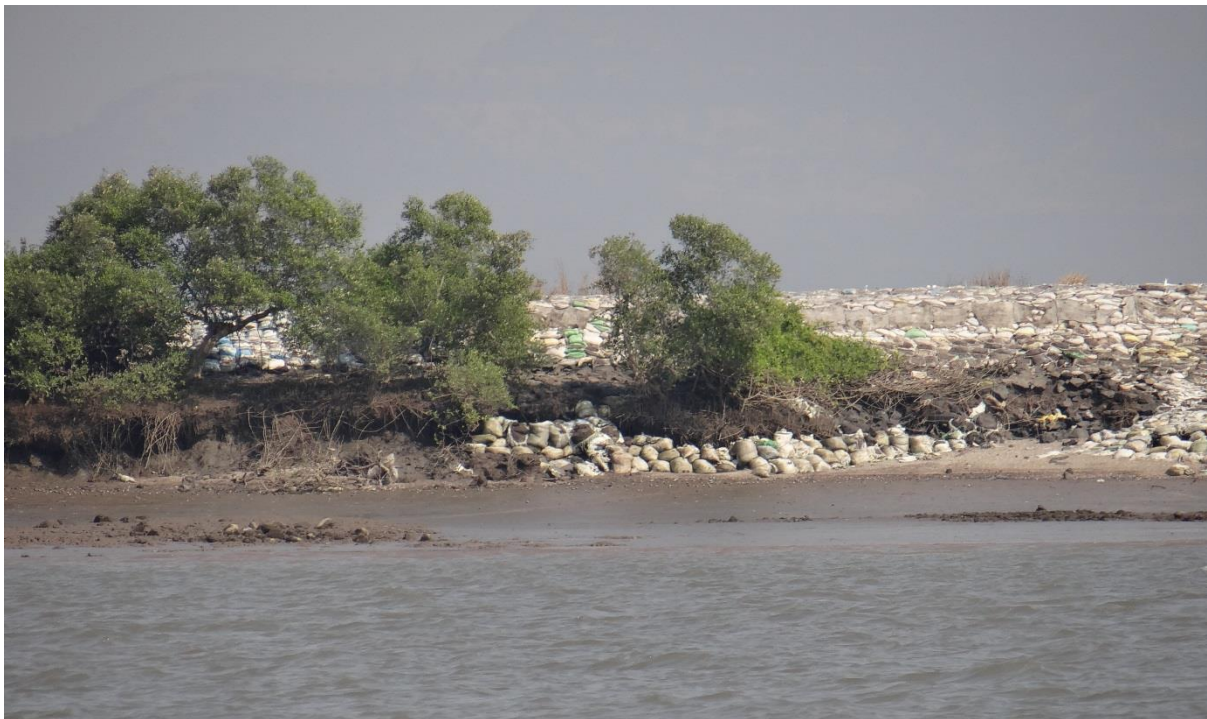
*Fig. 33: Bank erosion (as observed at 18° 46.98'N, 73°0.052'E), downstream of Amba River*
