**Subject: Compliance status of Environmental Clearance for Captive jetty at Dharamtar, Dolvi, Raigad, Maharashtra**

## COMPLIANCE STATUS OF CAPTIVE JETTY AS PER ENVIRONMENTAL CLEARANCE UPTO MAY, 2018

*Report on*  
**Monitoring - Expansion of Dharamtar Jetty facility  
at Dolvi, Raigad, Maharashtra**

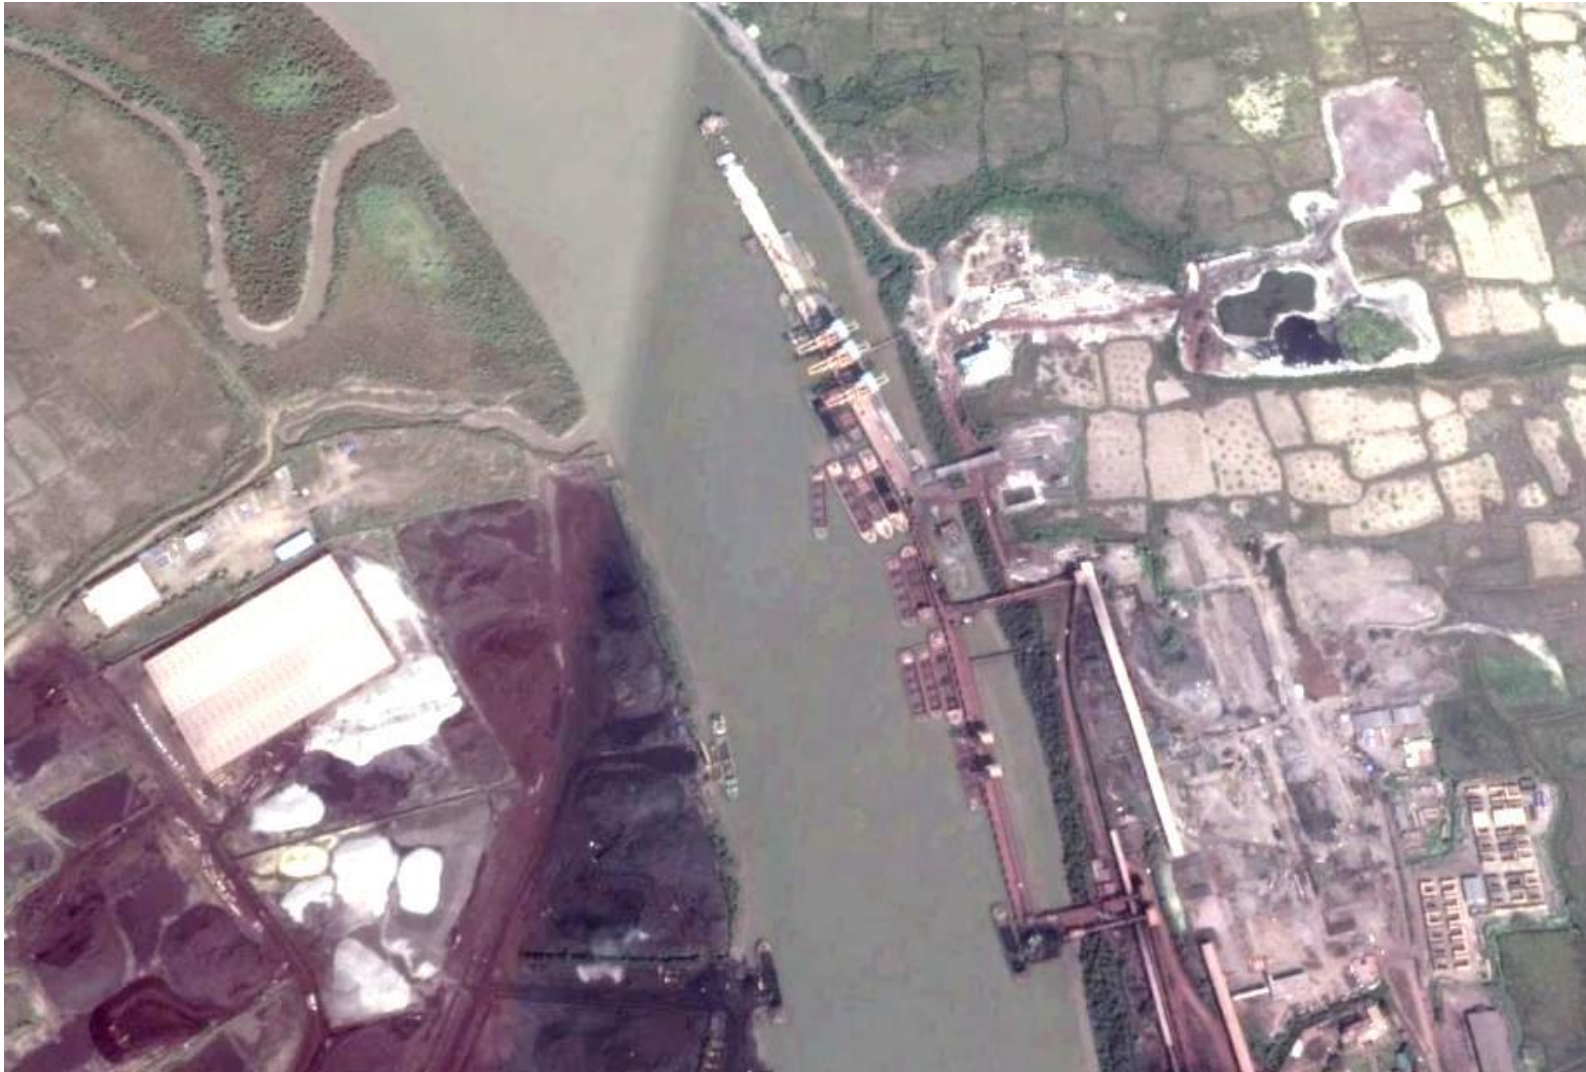
*Fig. 4: JSW Dharamtar Port Private Limited showing the existing berth and ongoing construction  
(as on 22<sup>nd</sup> Oct 2016; Google Earth Image)*

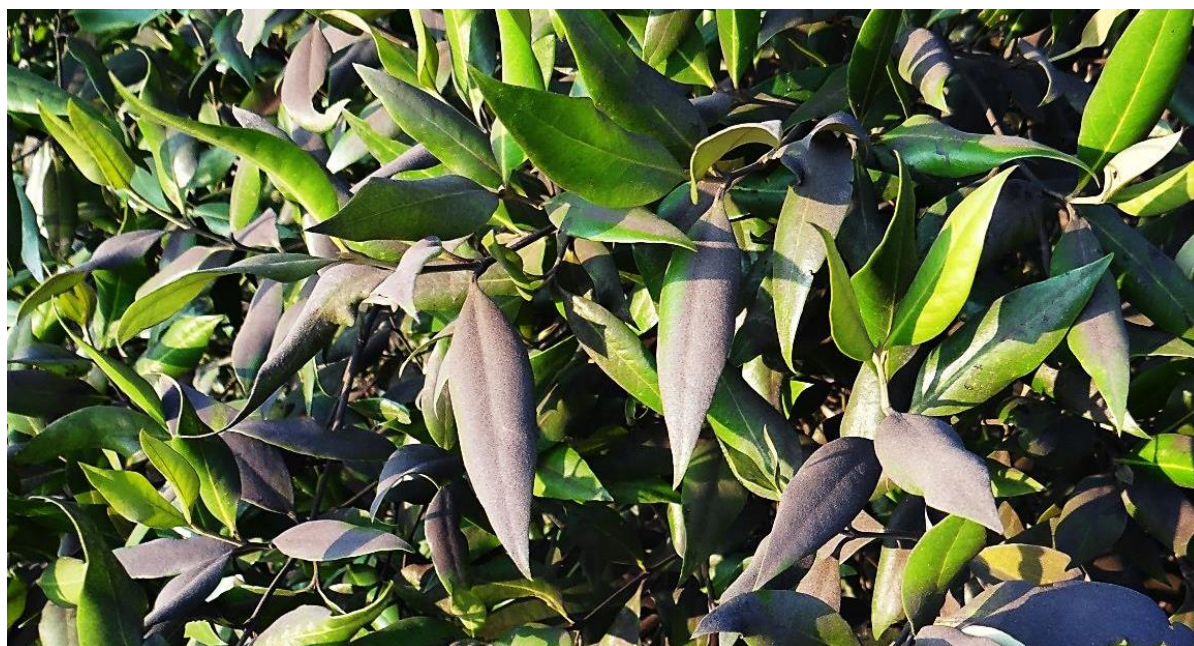
*Fig. 6: Deposition of fine dust on mangrove leaves near Dharamtar Jetty.*
